# **Debris/Ice/TPS Assessment and Integrated Photographic Analysis of Shuttle Mission STS-90**

*Gregory N. Katnik  
Process Engineering/Mechanical System Division/ET-SRB Branch,  
Kennedy Space Center, Florida*

**17 April 1998**

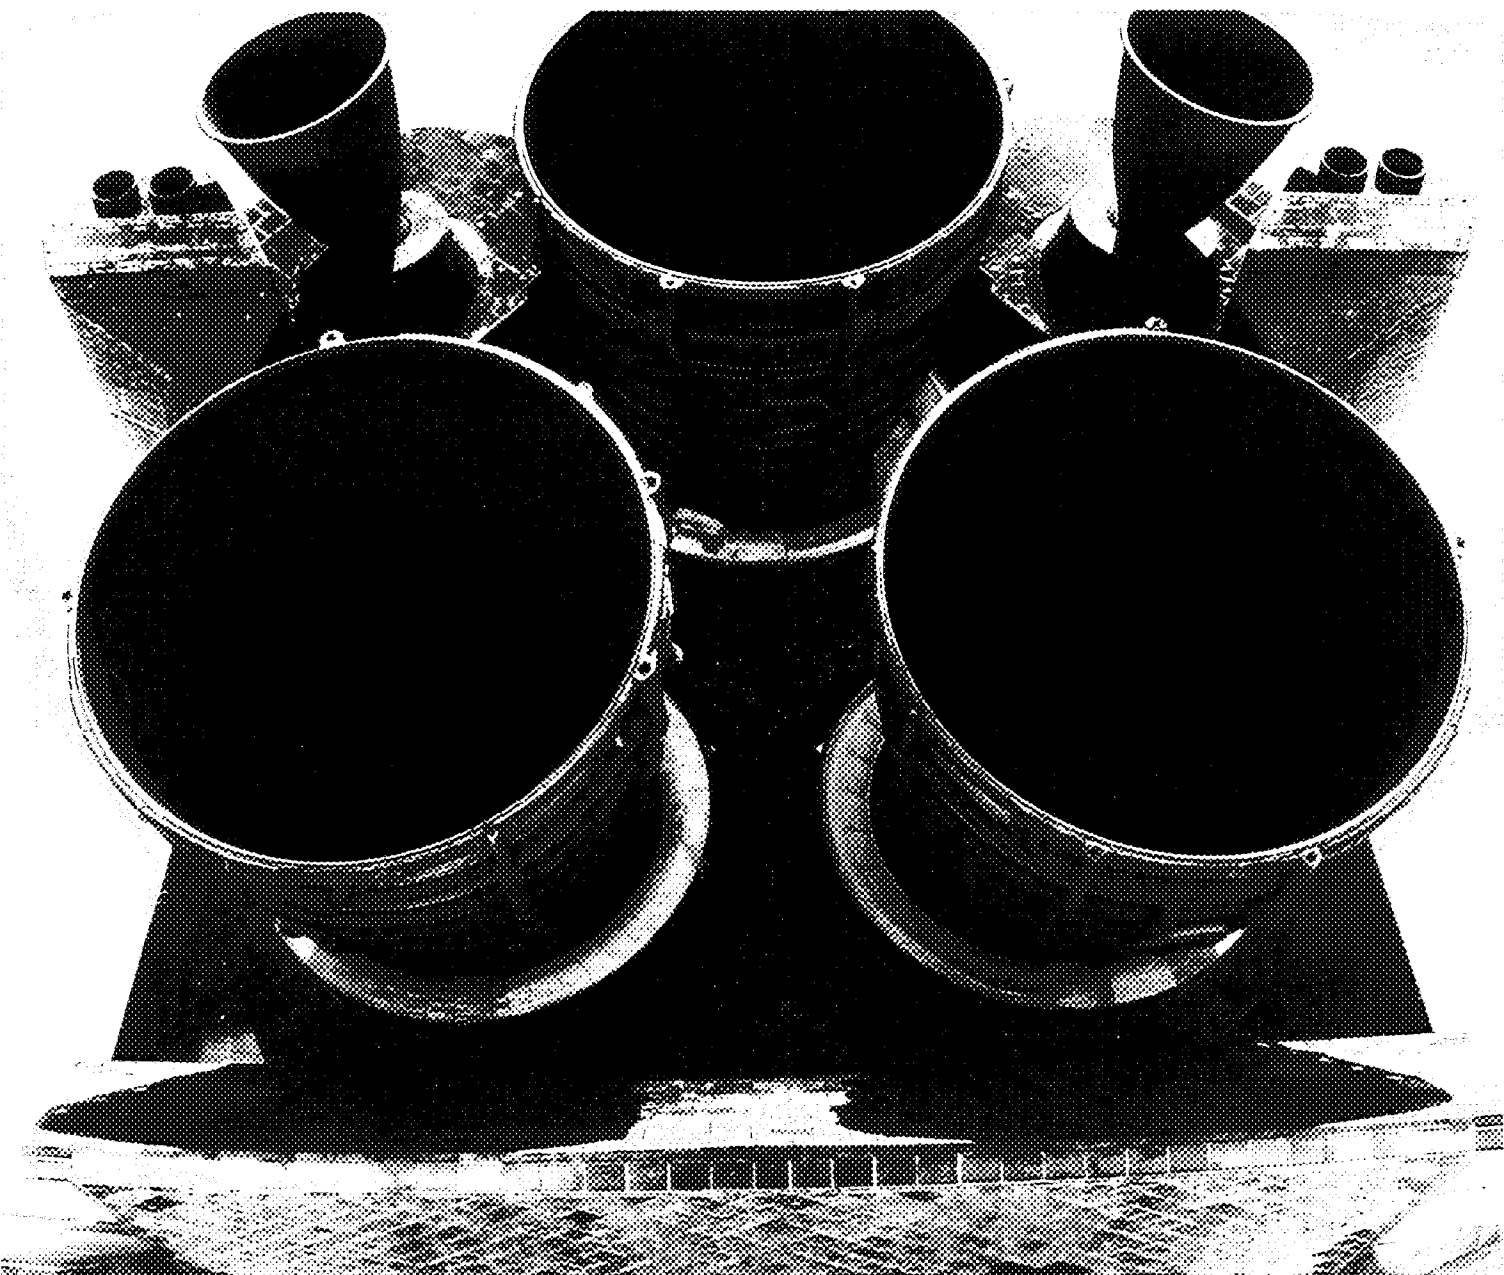
**Photo 24: SSME's/Base Heat Shield**

Typical amounts of tile damage occurred on the base heat shield due to exhaust plume acoustics and recirculation. Generally, the SSME Dome Mounted Heat Shield (DMHS) closeout blankets were in excellent condition. However, the blanket panels on SSME #1 at the 7:00 o'clock position were torn/frayed with missing batting material. This missing material may have been the white object falling aft of the SSME area during ascent at 47 seconds MET in the launch films.

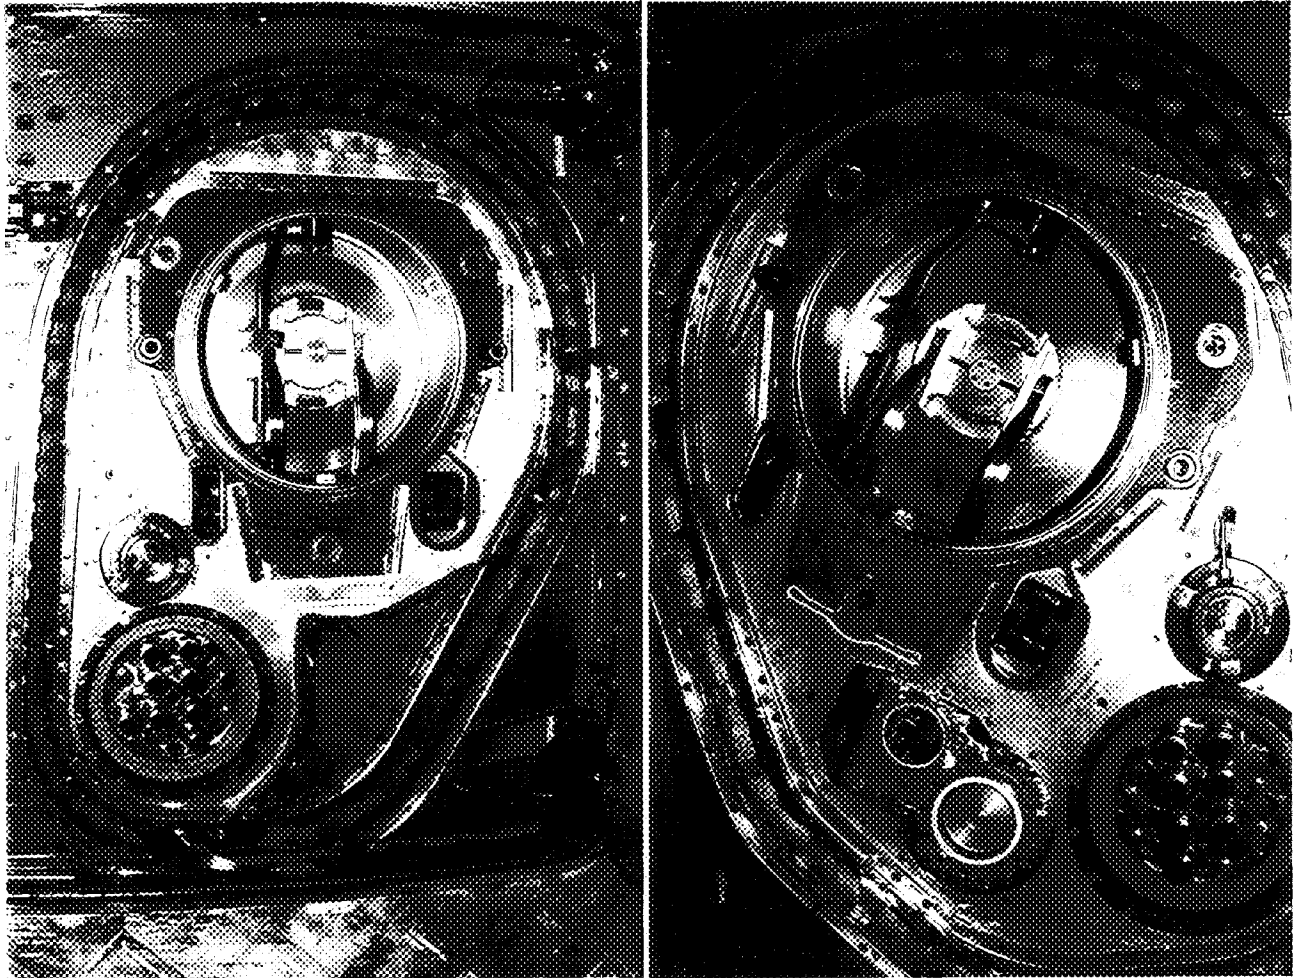
**Photo 25: LO2 and LH2 ET/ORB Umbilicals**

Note closeout foam and RTV along the edge of the umbilical plate aft of the 17-inch disconnect on the LO2 umbilical (left photo).

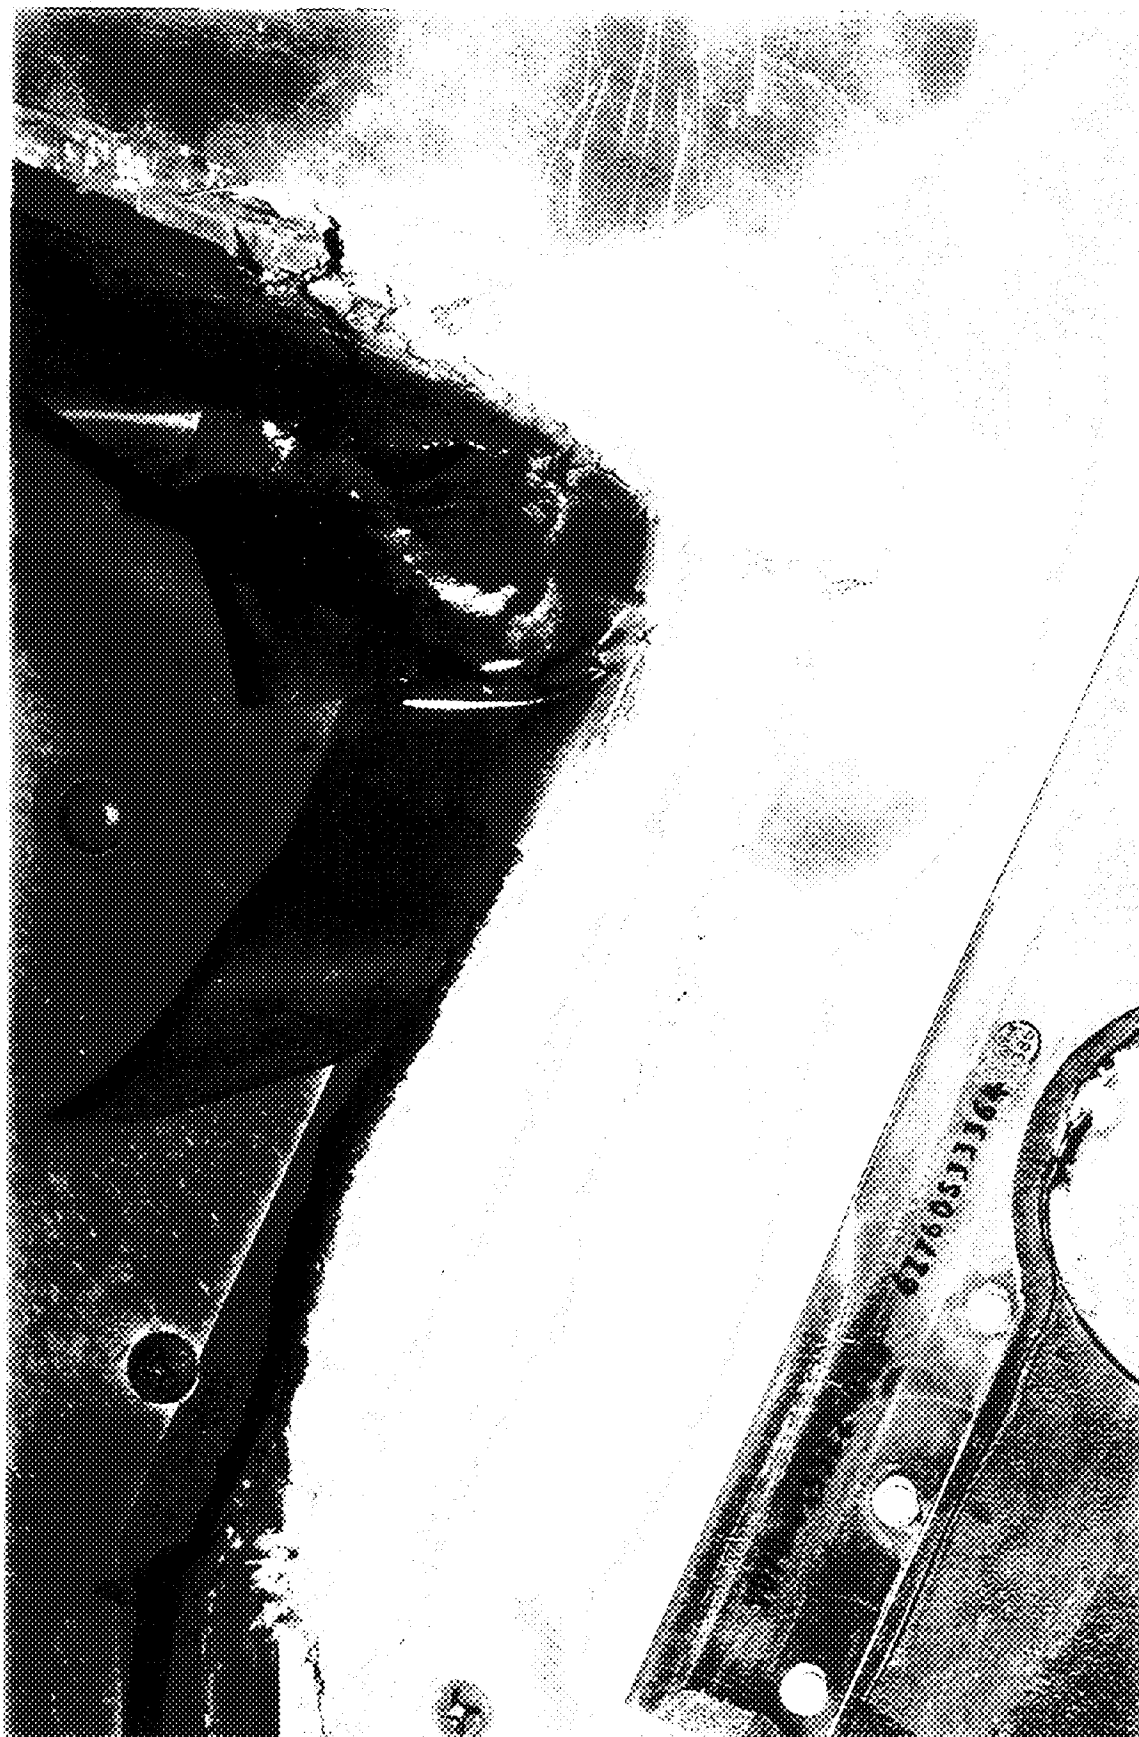
**Photo 26: Excess Closeout Foam**

An excessive amount of umbilical closeout foam (an “L”-shape 7-inches long by 3 inches on the perpendicular side) adhered to the umbilical plate aft of the 17-inch disconnect.

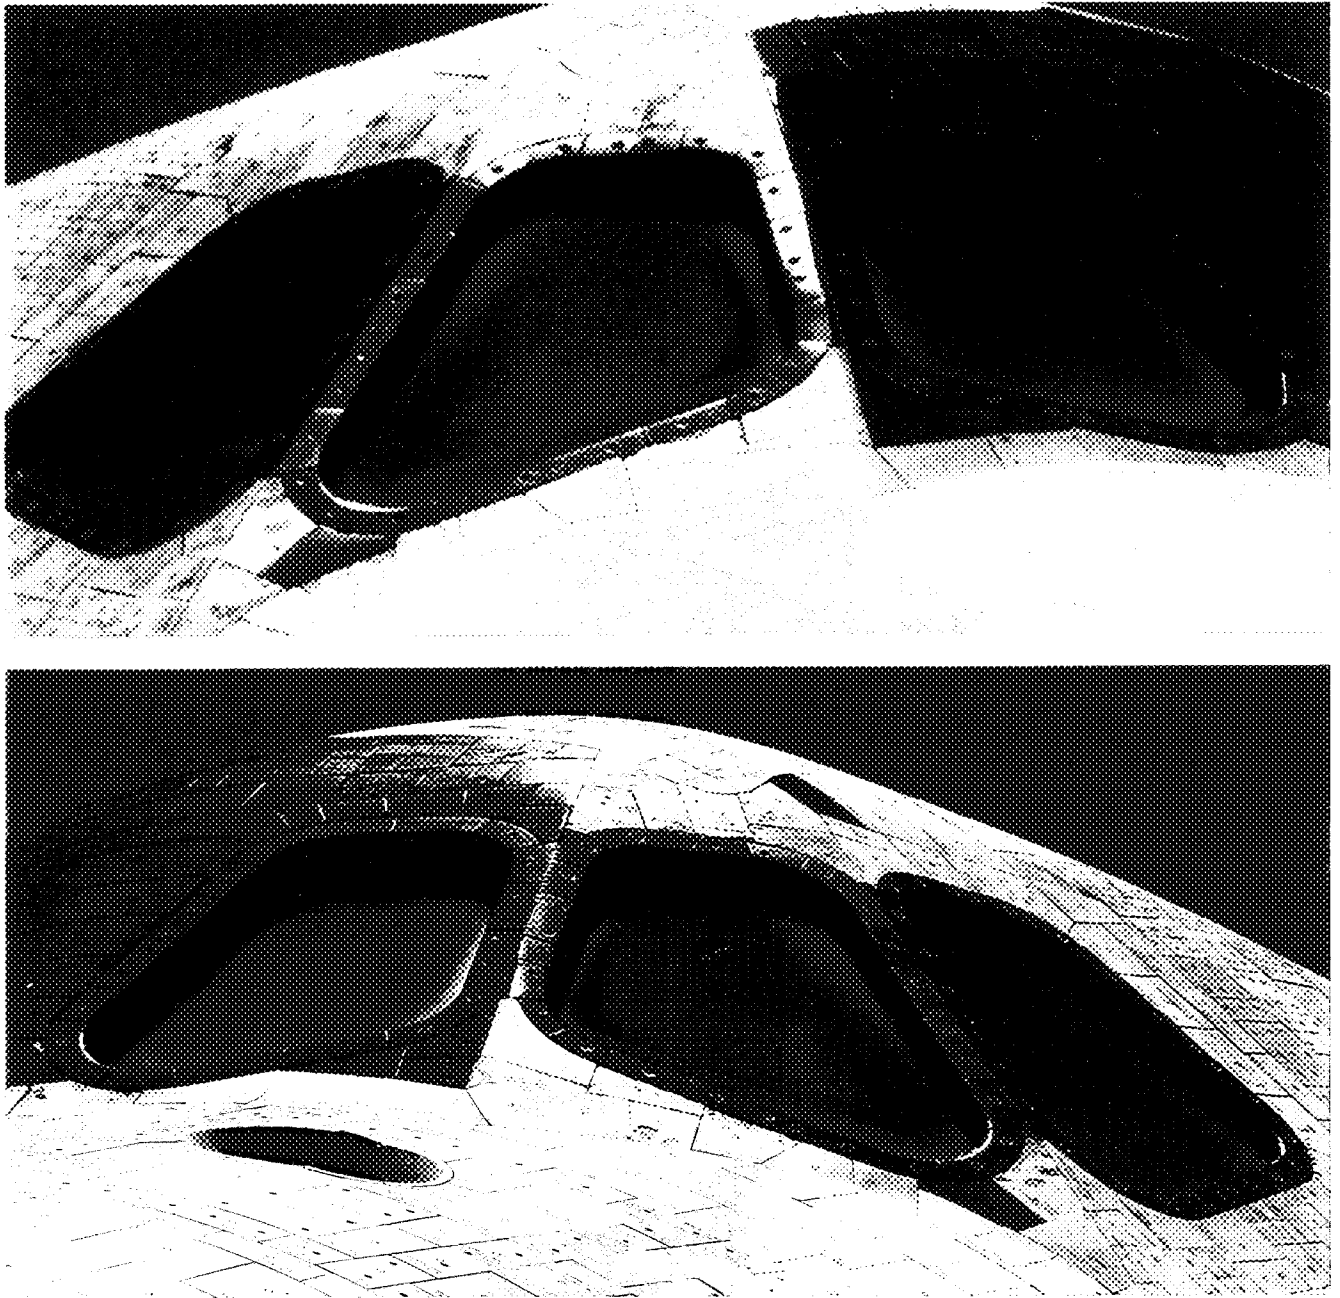
**Photo 27: Windows**

Hazing and streaking of forward-facing Orbiter windows was moderate to heavy. Damage sites on the window perimeter tiles was less than usual in quantity and size. The larger damage sites were attributed to old material falling out and were not included in this assessment.

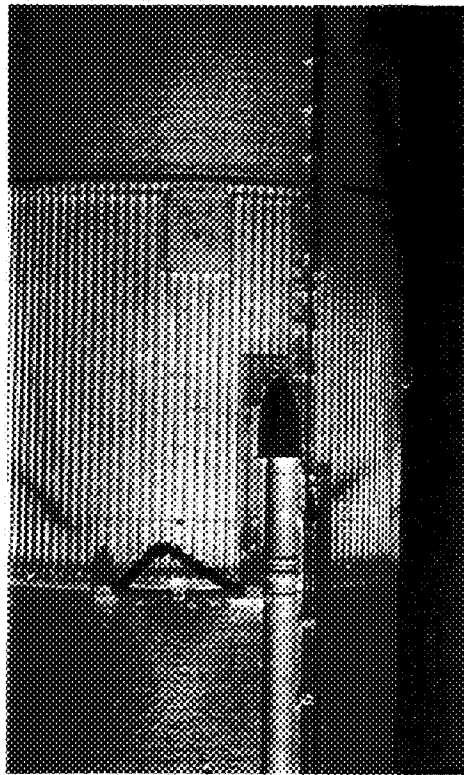
Figure 2.5.1 (B) View of +Z ET Intertank Area

No damage to the visible portion (+Z/+Y) of the right SRB thrust panel was noted on the 35mm umbilical well film (the left SRB thrust panel is not imaged). A divot, approximately four to five inches in size, is visible under the ET/Orbiter attach bipod in the LH2 tank-to-intertank closeout flange. A divot, approximately three inches in size, is visible in the -Y direction from the forward bipod on the LH2 tank-to-intertank flange closeout. A small divot is visible in an aft intertank stringer head forward of the LH2 tank-to-intertank closeout flange in the +Y direction from the LO2 feedline. A possible three inch divot is visible in the LH2 tank TPS aft of the right leg of the forward bipod next to the -Y side of the LO2 feedline. Dark-colored linear-shaped marks, possibly from shock waves off the EB fittings, were visible extending across the intertank stringer heads.

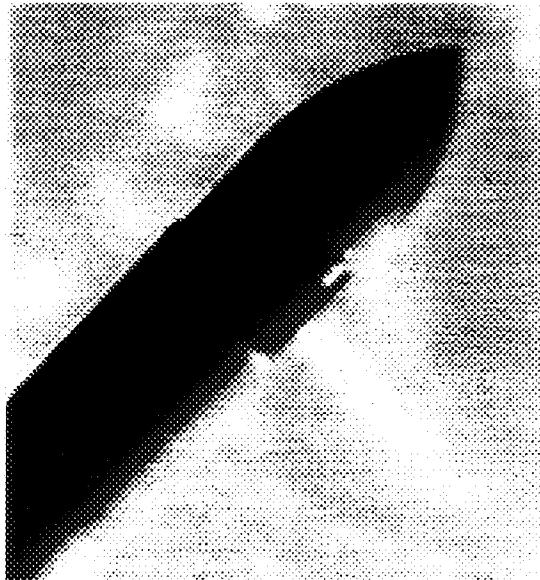
Figure 2.5.2.2 ET Intertank Venting

Approximately twelve minutes of downlink video of the STS-90 external tank (ET) was received. No anomalies to the ET were confirmed during the screening of the video. Venting was clearly visible from both the ET intertank vent area and the aft ET/Orbiter umbilical attach areas. The venting in the region of the ET intertank vent was visible for twenty seconds. Approximately six minutes later, a three second period of venting was seen coming from what appeared to be the LO2 ET/Orbiter umbilical. After three more minutes, a 170 second period of venting was visible originating from the LH2 umbilical. The tumbling motion of the ET did not appear excessive. The ET rate of tumble, i.e., the end-to-end rotation of the ET about its center of mass, at the beginning of the video sequence was estimated to be approximately three degrees/second. The rate of roll about the ET X axis appeared to increase after the intertank venting began. As noted on the two previous roll-to-heads-up flights, debris (probably ice) were visible during the video sequence.
